Manhole Inspection Summary

Manhole # S29EE2006MH

Insp Date: **10/2/08 2:10 PM**

Location Address: **5713 CHARLES ST**

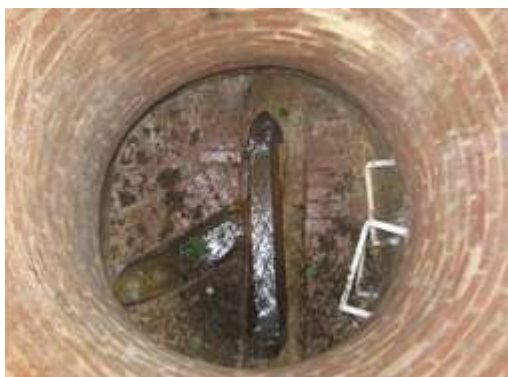
Top View

Evidence of surcharge - Bench debris.
Channel debris.

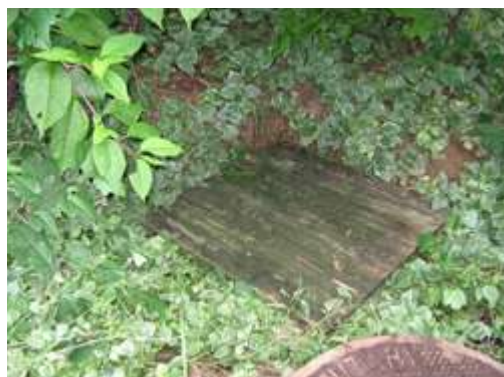
Sink hole

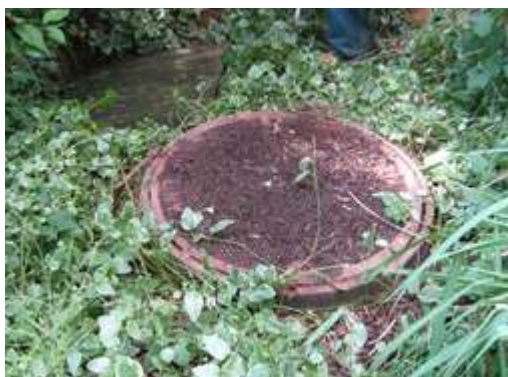
Defect

Above grade.

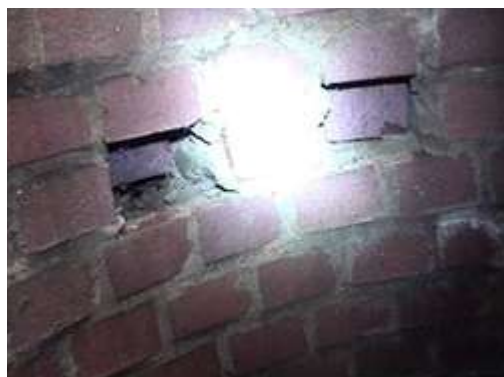
Defect

Infiltration: ☐ None ☐ Joint ☐ Cracks ☒ **Mortar** ☐ Roots ☒ **Wall**

Barrel infiltration.

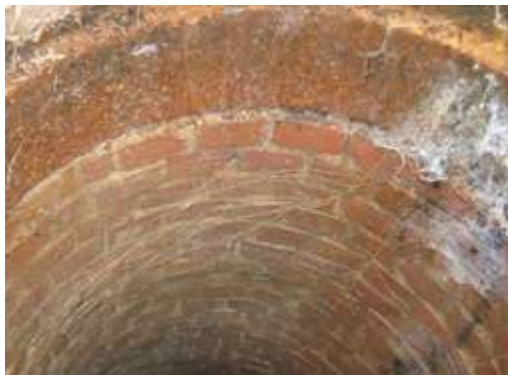
Defect

Condition: ☐ Sound ☐ Cracked ☒ **Root Intrusion** ☐ Loose Brick ☐ Deteriorated

Infiltration: ☐ None ☒ **Joint** ☐ Cracks ☐ Mortar ☒ **Roots** ☐ Wall

Corbel root intrusion and infiltration

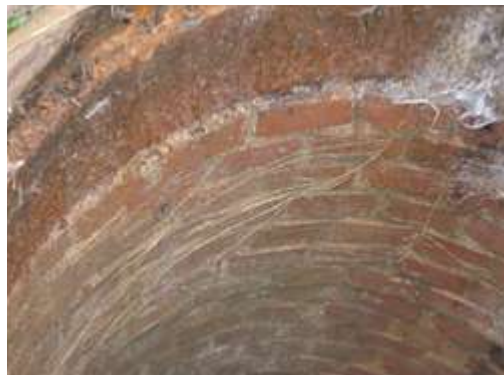
Defect

Corbel root intrusion and infiltration.

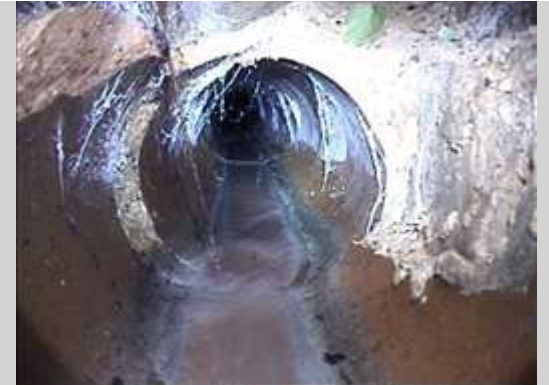
8 in. Circular Gravity Sewer Pipe Out @ 12 O'Clock

Infiltration: **Evidence** Pipe Seal Cond: **Broken**
